JAMES E. ROGERS ENERGY COMPLEX (FORMERLY CLIFFSIDE STEAM STATION) RISK CLASSIFICATION

James E. Rogers Energy Complex Overall Risk Classification

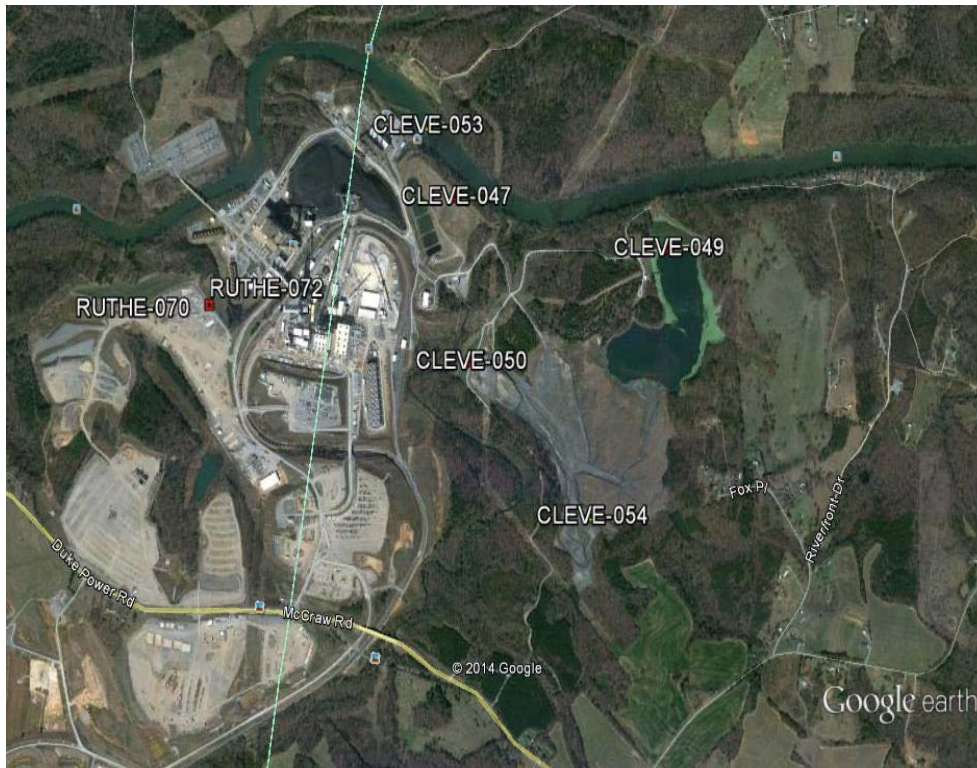
- State of Structural Stability and Maintenance:
 - Active Ash Basin (CLEVE-049 & CLEVE-050). **HIGH RISK** before repairs are made. **LOW RISK** after repairs are made. This impoundment received a notice of deficiency with structural deficiencies. The following modifications/repairs to the dam have been submitted and should be completed, as a minimum: slope improvements, grout pipe, and installation of a new spillway.

- Retired Unit 1-4 Basin (CLEVE-047). **LOW RISK**. This impoundment received a notice of inspection. The following modifications/repairs to the dam have been submitted and should be completed, as a minimum: vegetation removal, grout pipe, and remove toe drains.

- Retired Unit 5 Basin (RUTHE-070 & RUTHE-072). **HIGH RISK** before repairs are made. **LOW RISK** after repairs are made. This impoundment received a notice of deficiency with structural deficiencies. The following modifications/repairs to the dam have been submitted and should be completed, as a minimum: slope improvements, grout pipe, and installation of graded filter.
